## Sliplined Pipe to the Rescue

*How a slipline installation helped avert a disaster after a sewer main line collapsed*

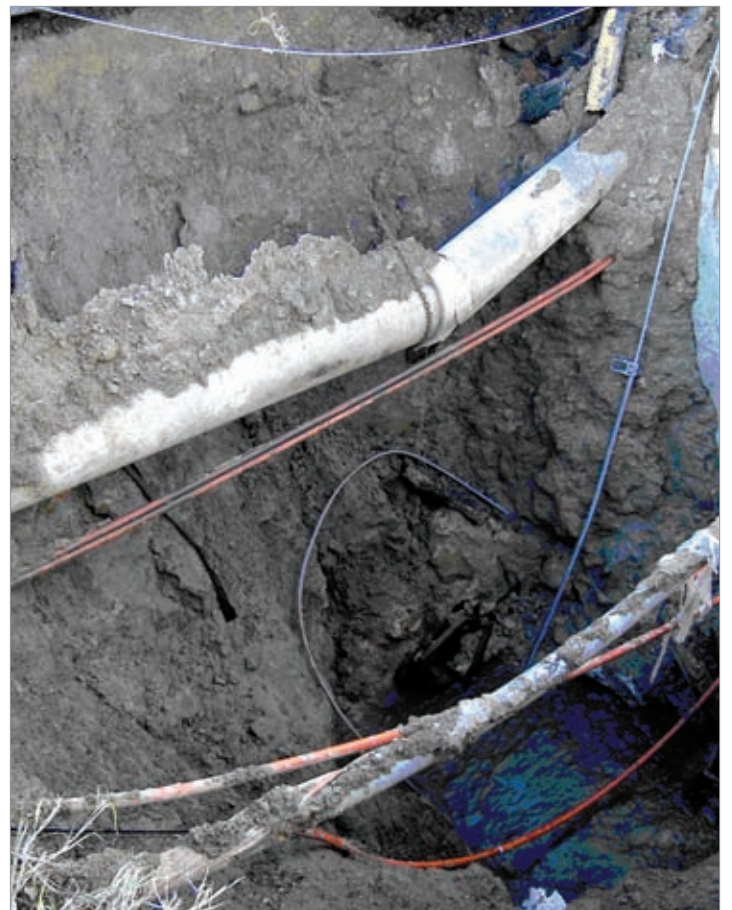
A fast response by the contractors, government agencies and a major pipe manufacturer prevented catastrophe. The contractor, Allen & LeBlanc, Inc., was contacted to excavate the shoulder between the Essen Lane roadway and the edge of the asphalt parking lot. They found that the failure was apparently caused by the collapse of the top of a 54-in. RCP gravity sewer main located approximately 25 ft below the surface. The Entergy crews also arrived to remove the pole and reroute the electric lines.

The Essen Lane collapse exposed the failure in the top of the 54-in. RCP sanitary sewer gravity main. At the top, a 15-in. potable water main is broken and numerous other utilities are adjacent, including telephone, cable and fiber optic lines.

The existing sewer line was a 54-in. RCP gravity sewer main. DPW's intent was to repair the failed section by installing fiberglass sliplining pipe between the upstream and downstream manholes. The lead times were too long for the several local fiberglass manufacturers and suppliers they had contacted. They had to find one that could provide the required pipe at a good price in a short time.

The plan was to use the CCFRPM pipe to slipline the failed sewer from the failure point, which was located just outside of the upstream manhole, to the downstream manhole where quality connections could be made to the existing system.

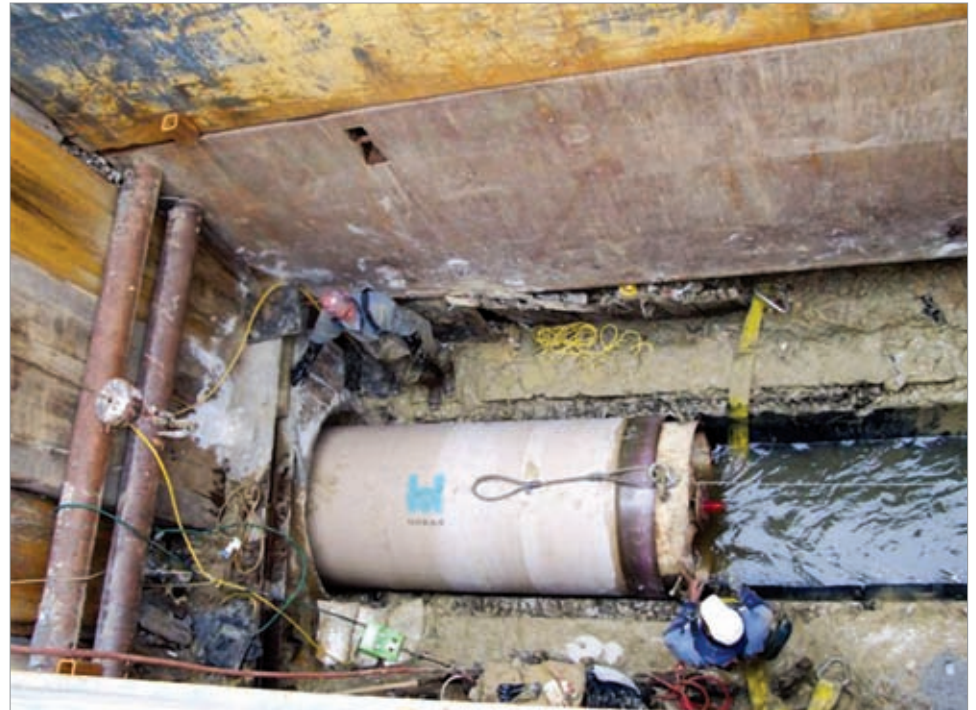
Allen & LeBlanc crew members slipline the 48-in. HOBAS CCFRPM pipe into position. The integral fiberglass low profile bell is gasketed and provides a watertight seal with the spigot joint while allowing the pipe to be pulled or jacked into the host pipe. The low profile design prevents hang-ups and minimizes friction during installation. The entire project was approximately 400 ft long.

All utilities were relocated and all repair materials and equipment were on site by February 2007. At that time, Allen & LeBlanc set up the necessary equipment to maneuver the 20-ft joints of CCFRPM pipe into the working pit and install them. Once sliplining operations began, Allen & LeBlanc worked into the evening hours to ensure that the project was completed.

Following the sliplining operations, they grouted the liner pipe to the existing sewer system at both ends to insure a tight seal. Backfill of the system was performed to DPW standards and the site was dressed to pre-construction conditions. **WWD**
