Standing the Test of Time

Inspecting large-scale HDPE pipe after 20 years

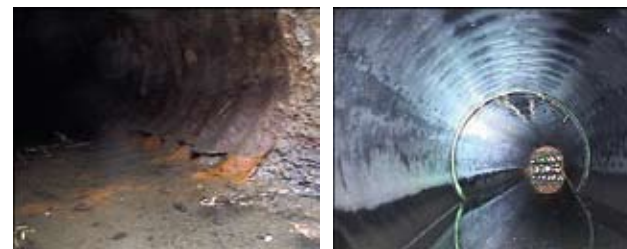
Each of the cross pipes inspected is subject to the same HS-25 loads and has almost the same pavement section. Because the ADT loadings are excessively high in the summer months, these pipes were selected for the inspection. After the pipe evaluations were completed, all pipes inspected were found to have no defects that would affect their long-term performance.

Left: Steel pipe is susceptible to corrosion from saltwater. Right: An inspection photo showed no signs of soil migration through the joints or visual deflection of the pipe.
