Pipeline Rehab Survives the Elements

Projects rarely are easy. However, throw in a remote site, steep siphon, a limited number of access points, harsh winter conditions and environmental concerns and you have a daunting project. This was the task facing Spiniello Companies' Western Division who were asked to save 8,800' of 184"-diameter pipeline.

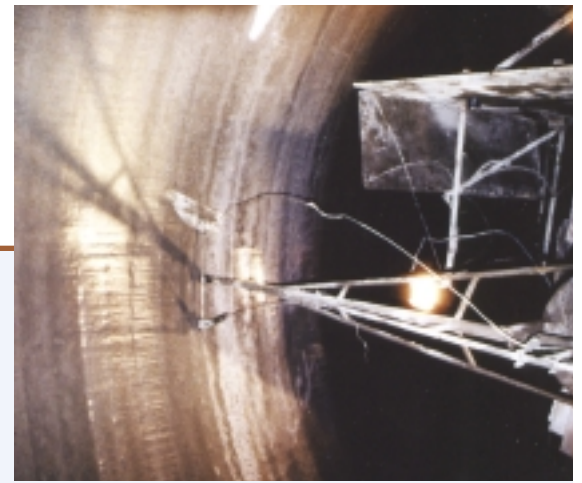
The crew applies the cement mortar lining to the inside of the 184"-diameter pipeline. ▶

The next step was installing the new lining. Chuck Garbe, director of marketing and sales at Spiniello, describes the new cement mortar lining inside the pipe surface as one that creates a chemical shield that permanently prevents rust from forming between the lining and the pipe.

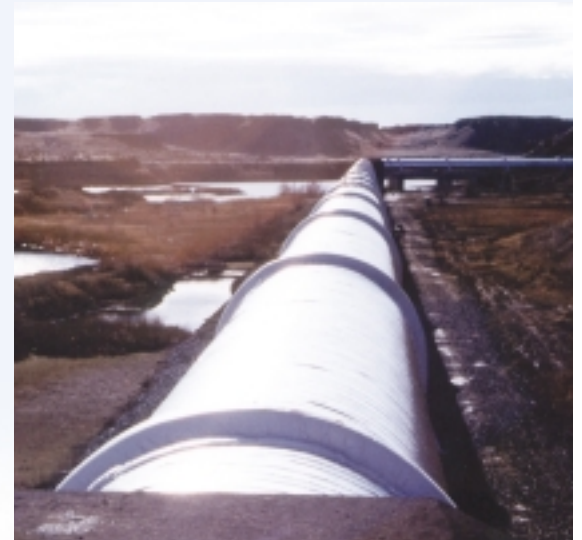
▶ Portions of the 8,800' pipeline were elevated 20'-25', making this project particularly challenging. ▶

- 2,474 of the 8,800 linear feet of pipe were elevated 20'-25' off the ground.
