Cold-Weather Cure

By Dr. Peter S. Fiske

Active mixing helps prevent tank ice formation

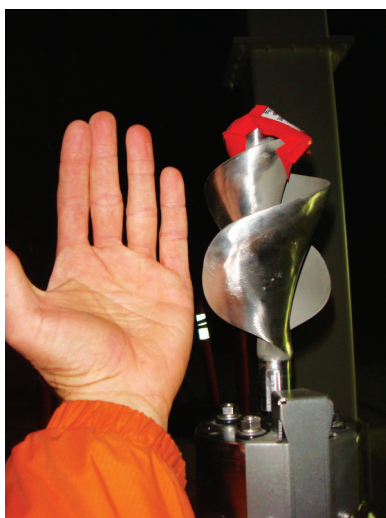
The small size of the system made it easy to install and operate.

Installation of the mixer was relatively simple, only requiring 110-V electrical power, which was available at the tank. “The installation of the mixer was quite easy,” said Richard Steckel, former water superintendent for the town of Girdwood. “Some of our guys were surprised at how small the device was. They thought it looked like a margarita maker.”

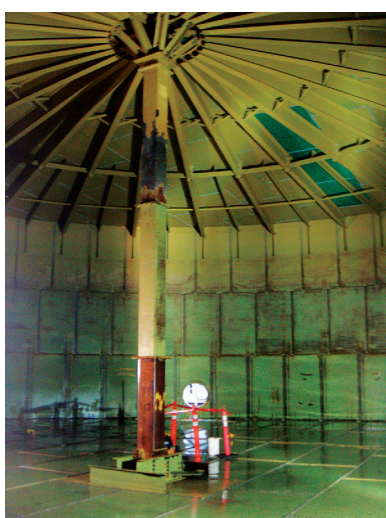
Interior of the Girdwood tank showing damage to the center column

ROV inspections of the tank interior showed some damage to the interior tank coating, especially around the central column that supports the roof. In order to prevent corrosion of the exposed tank interior, operators took the tank down for closer inspection and coating repair.

With the tank drained, operators discovered that the interior damage was far worse than the ROV inspection had revealed. In addition to significant areas of coating damage, ice had twisted the center column out of place. While the cost of repairing the coating damage and realigning the column came to roughly \$20,000, the largest expense by far came from taking the tank offline and providing temporary storage and control—roughly \$100,000.
