Storage Tank Stands Up to Challenging Geology

The Windmill Gap tank project is located in southern West Virginia near the town of Bramwell on top of a mountain with an elevation of 3,400 ft. The construction of a 55,000-gal storage tank posed many challenges to the owner, Bluewell Public Service District; engineer, Stafford Consultants Inc.; general contractor, Chojnacki Construction; and tank provider, Tank Connection. The biggest challenge to overcome was the subsurface geology, along with old mine workings created from extracting coal from underneath the site over the past 60 years. The existence of the old mine workings was an intimidating problem, as it added risk to the project.

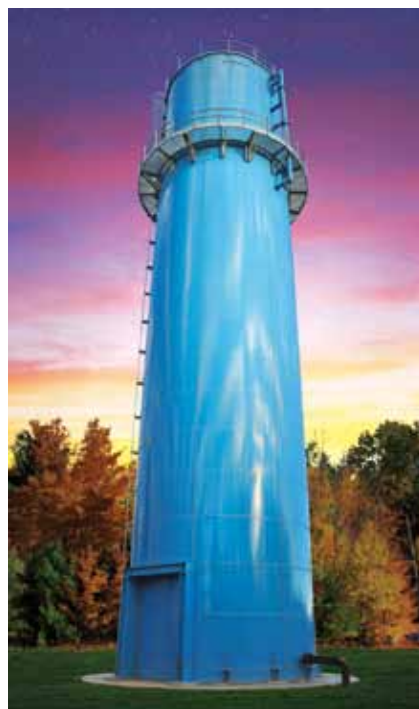
Tank Connection's Poster Series elevated water tank was selected because it met three out of four of the technical requirements. The series is available with a bolted steel pedestal. The bolted pedestal pictured at left utilizes RTP (rolled, tapered panel) construction. Tank Connection's coating systems are factory baked-on to a substrate surface that has been blasted to an SP10 (near-white) surface profile. The coating system utilized is LIQ Fusion 7000 FBE, a high-performance coating system for potable water storage tanks. Tank Connection is the exclusive provider of this system and maintains the only powder coat line certified to apply this coating for bolted water tank applications.
