## Rehabilitation of Raw Water Reservoir for Franklin WTP

Bill Shehane, P.E., Seaman Corporation, USA, bshehane@seamancorp.com

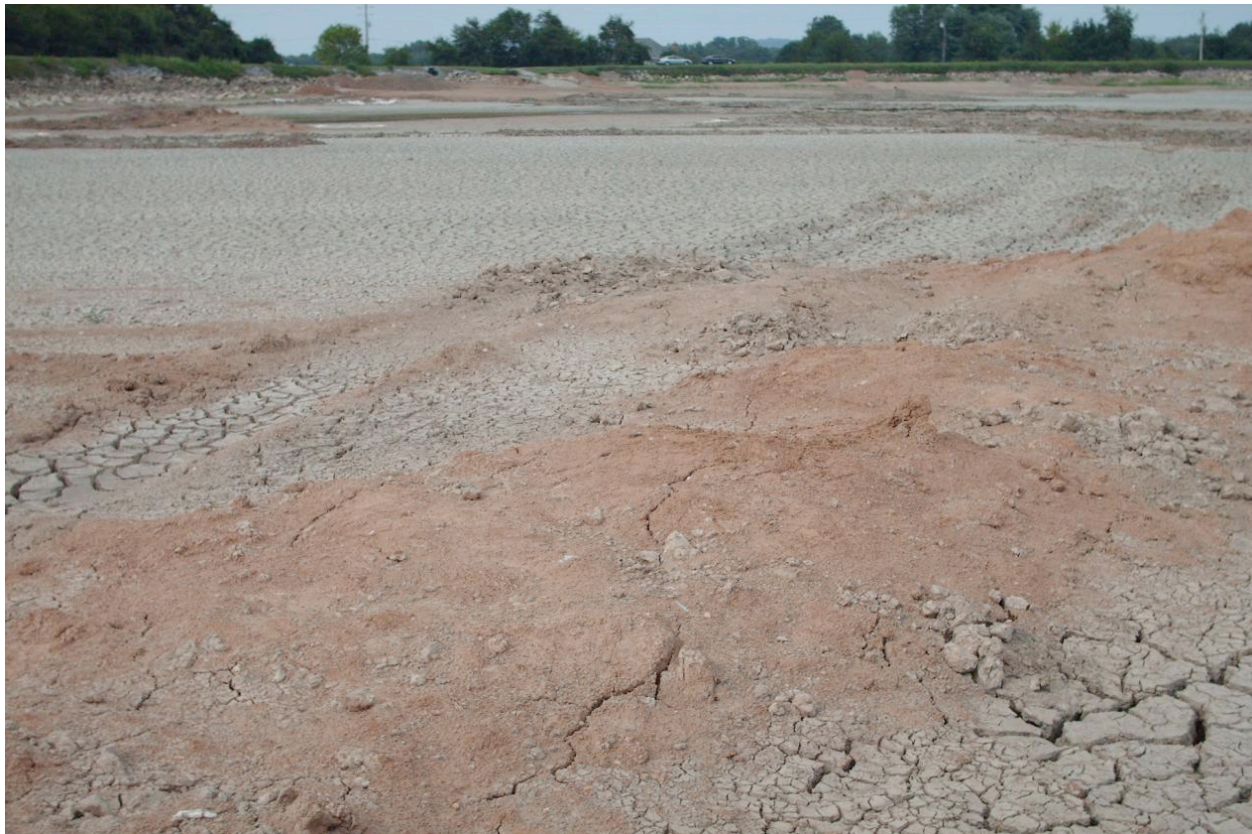
Figure 1: Reservoir in 2008 after the major drought of 2007

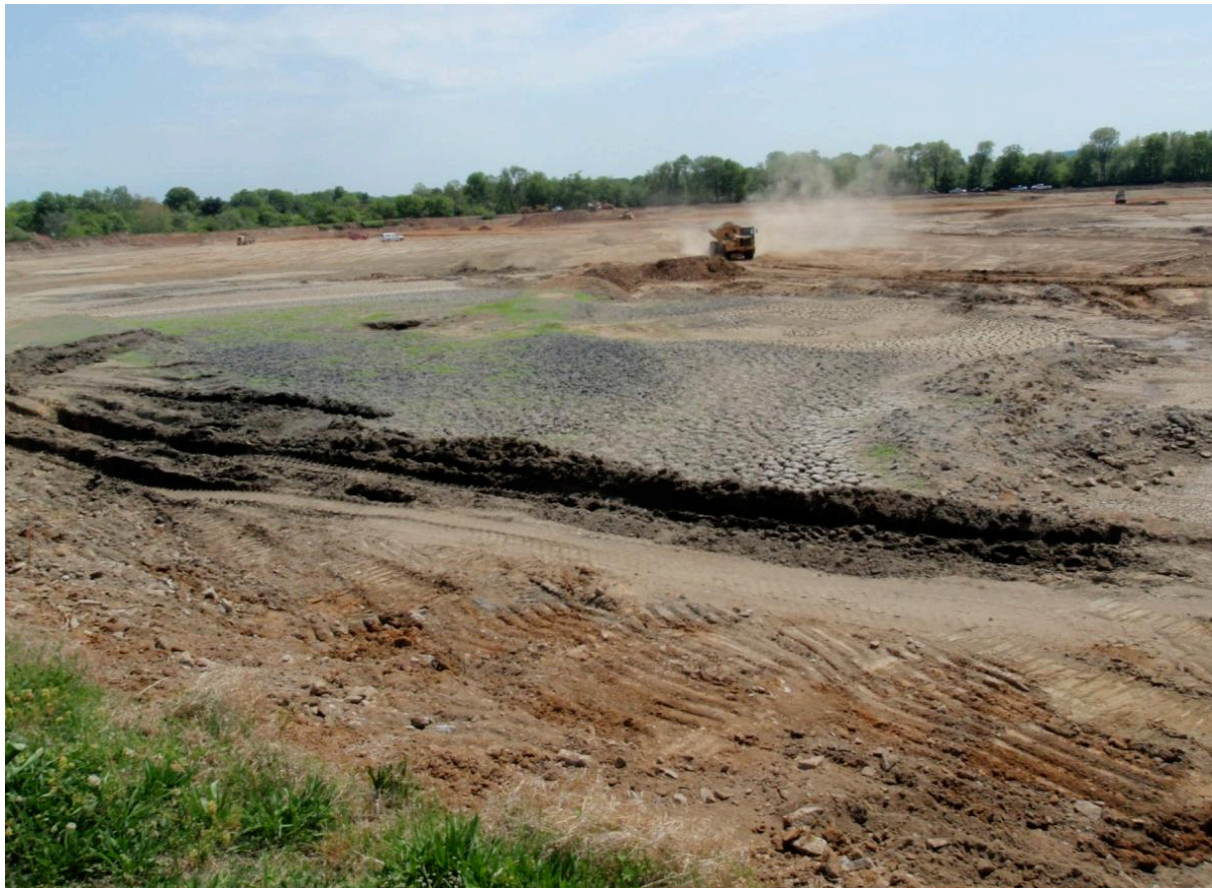
Figure 3: Disposal of filter backwash solids

The option chosen was to haul the filter backwash solids to a C+D landfill, which required 1,900 dump truck loads or a total of 33,000 cubic yards.

During the solids removal, numerous areas of soft spots were found. To fix this, large rip rap from the side slopes was used in these areas for stabilization of the soil. This was a great use for the rip rap, since it had to be removed from the sides of the reservoir anyway before installation of the geomembrane liner and geoweb system. The haul off and rough grading of the reservoir bottom took approximately 3 months to complete.

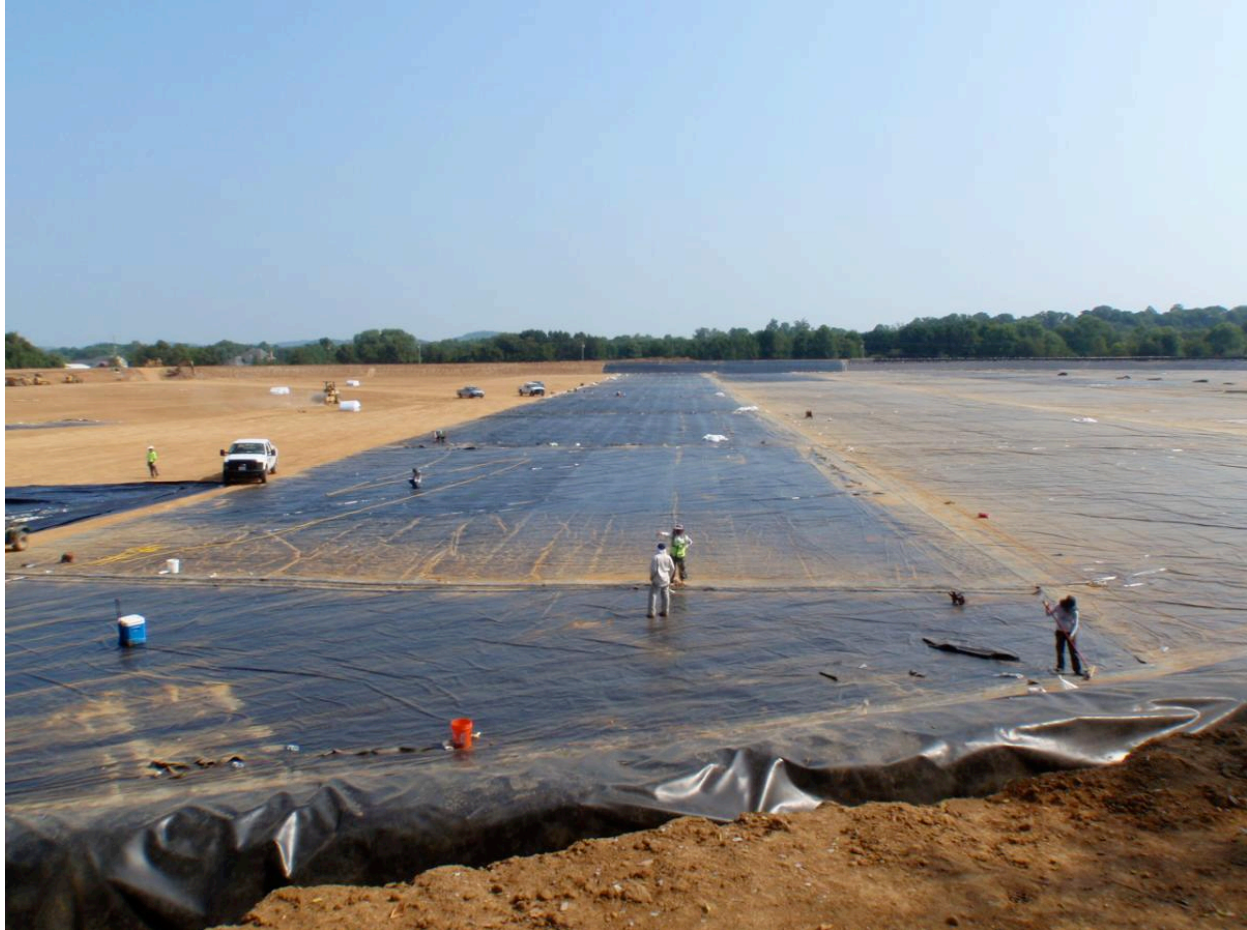
Figure 4: Geomembrane liner installation

Even though the reservoir will be holding “raw water” from the Harpeth River, the facility owner wanted the liner system to be NSF 61 certified for potable water. After one month of fine grading the reservoir bottom, installation of the geomembrane liner started. Since the geomembrane was a heavily reinforced coated fabric with excellent physical properties such as puncture resistance, a geotextile below the liner was not needed.

The EIA-R was prefabricated into panels 90 feet wide by 180 feet long (16,200 SF each). Fabrication of the geomembrane was performed by Colorado Lining International's New Caney, TX facility and installation of liner and geoweb was by Geosynthetics, Inc. (GSI). A total of 95 prefabricated geomembrane panels were delivered to the job site. This allowed for only 2 field seams per acre required, which dramatically reduced the amount of CQA testing in the field.

A thicker 45-mil reinforced EIA-R was installed on the side slopes since they will experience greater exposure to the elements and a 36-mil reinforced EIA-R was installed on the reservoir bottom. Liner installation was completed in approximately 2 months and required over 1.5 million square feet (35 acres). Sand tubes made out of the EIA-R were also placed along the bottom to prevent wind uplift when the reservoir is empty.

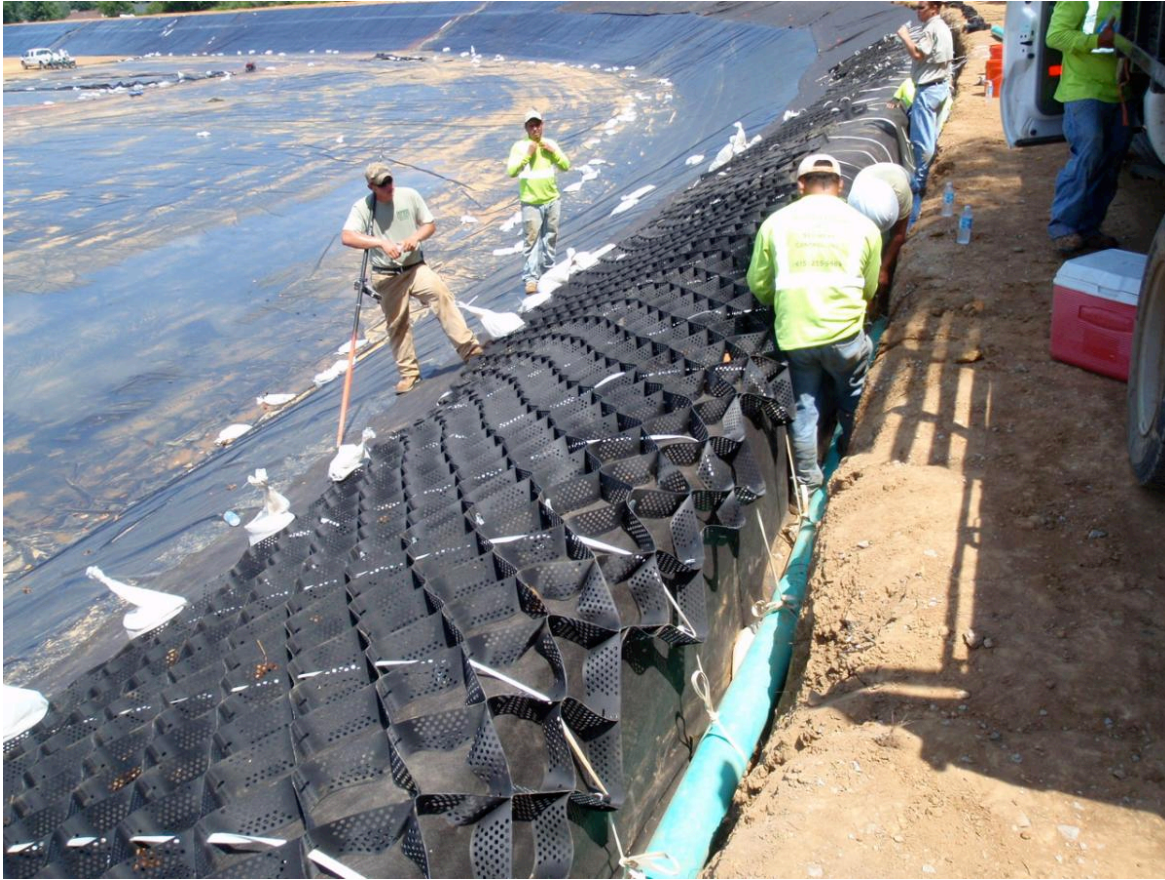
Figure 5: Installation of geoweb along the side slopes

Due to concerns from potential wave action when the reservoir is full of water, AECOM recommended a geoweb with stone be installed along the top of the side slopes and on top of the geomembrane liner. After the geoweb was in place, a concrete anchor trench was installed. The geoweb with stone was also placed below the 24" influent pipe to prevent scouring and as a ramp down to the toe of slope for vehicle access when needed.

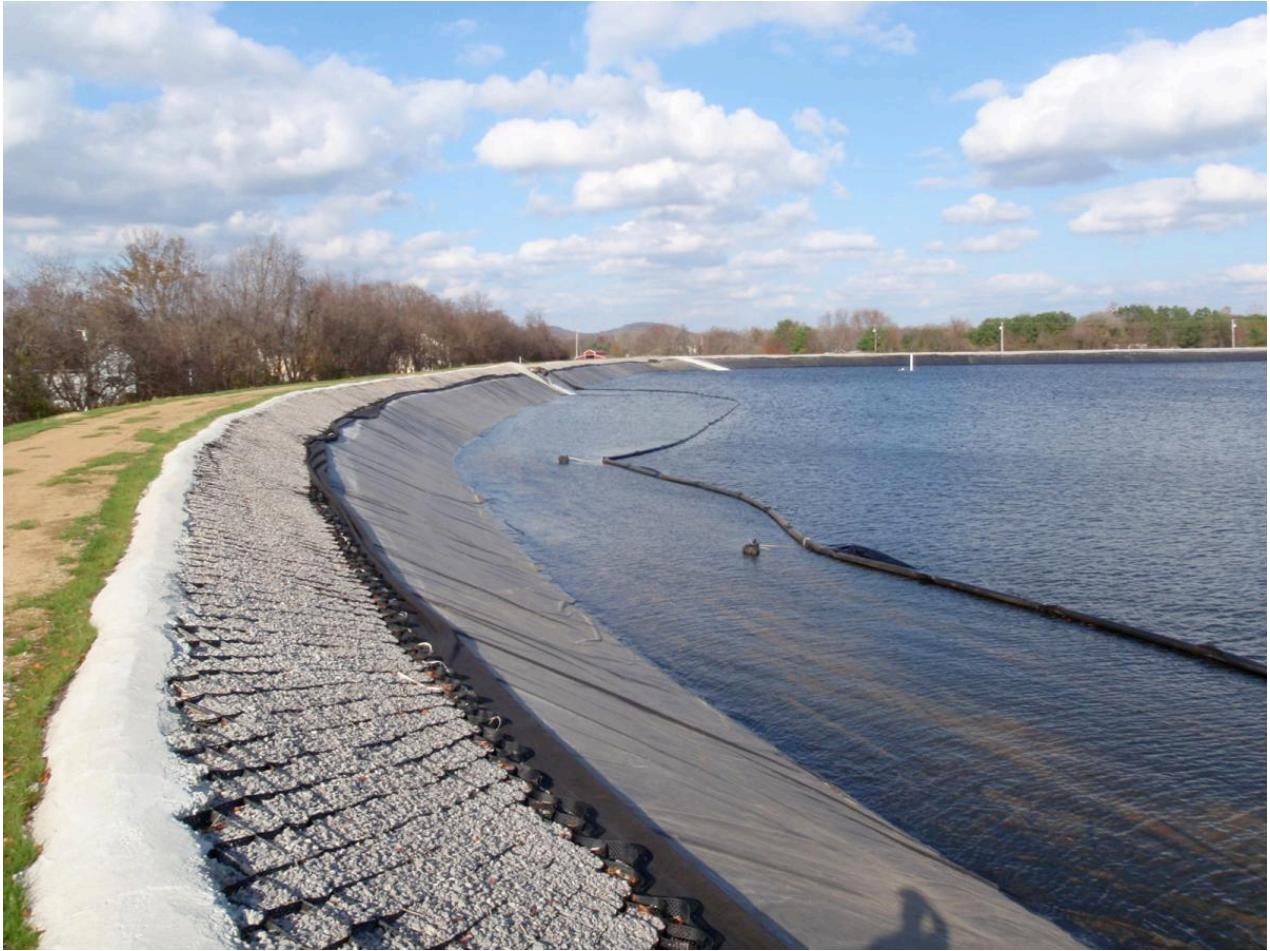
Figure 6: Completed reservoir rehabilitation shown now full of water

The Franklin reservoir rehabilitation project went out for bid in December of 2009 and the notice to proceed was given on April 1, 2010. The reservoir was operationally complete in October of 2010, with the final construction cost being over budget by only 1% (\$3,946,762). The general contractor was Summit Construction based out of Nashville, TN. Once completed, the reservoir achieved a total of 113 million gallons of storage which was 8% over the original design of 105 million gallons.
