Standing the Test of Time

Inspecting large-scale HDPE pipe after 20 years

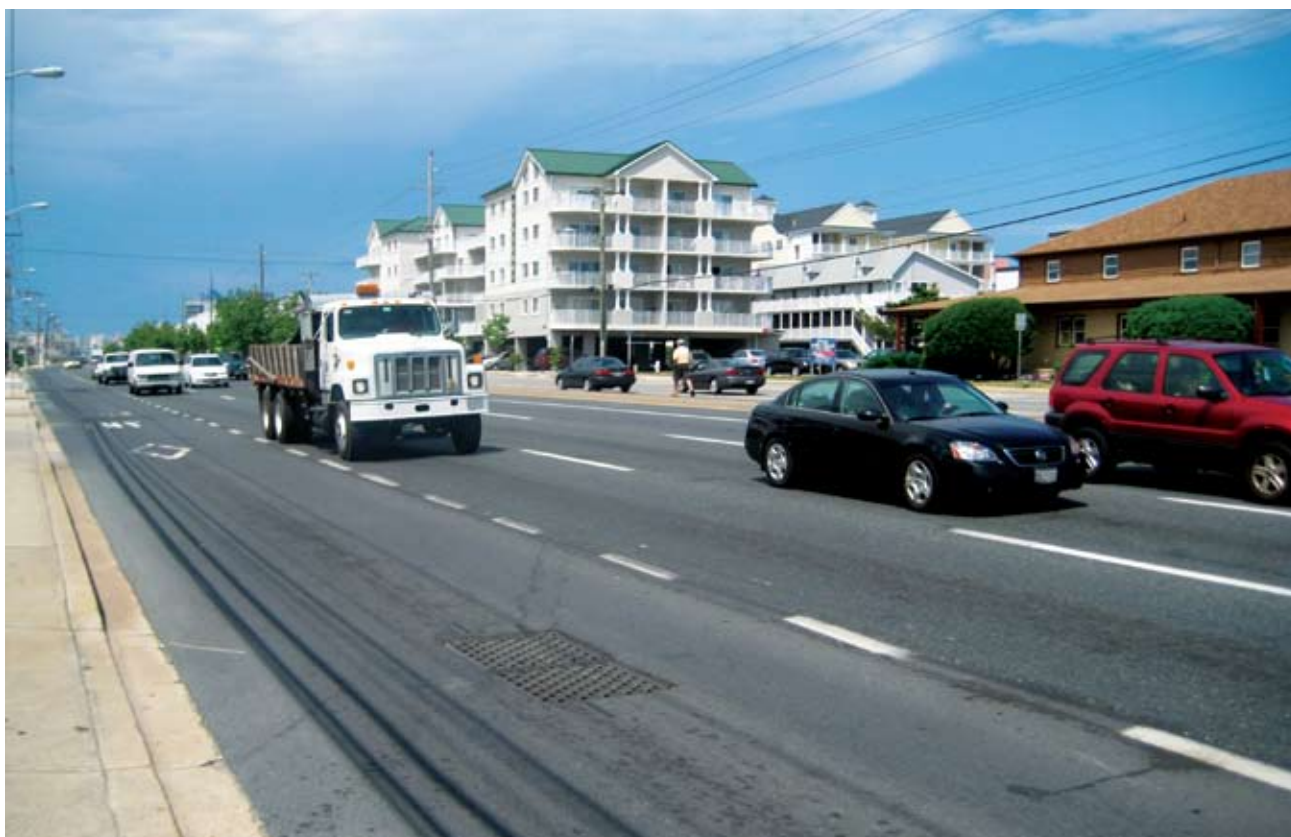
Ocean City, Md., sees traffic increase tenfold during the prime summer vacation season. HDPE pipe installed in 1987 has improved drainage for the past 24 years.
