Filter Rebuild

An Iowa treatment plant saves time and money by improving its backwash process

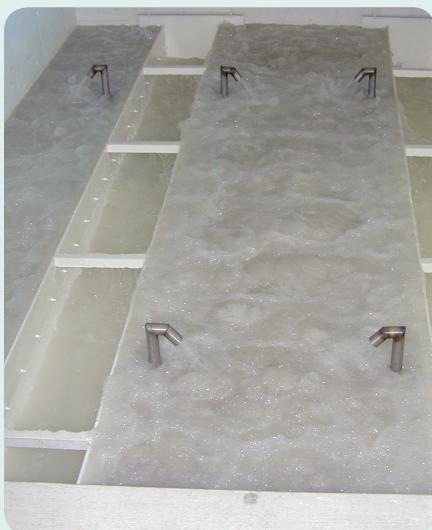
The new system started up in 2002 and has saved operator time and treatment costs.
