Coating with optically active pigment technology

### Optically active pigment shines light of longevity on water tower

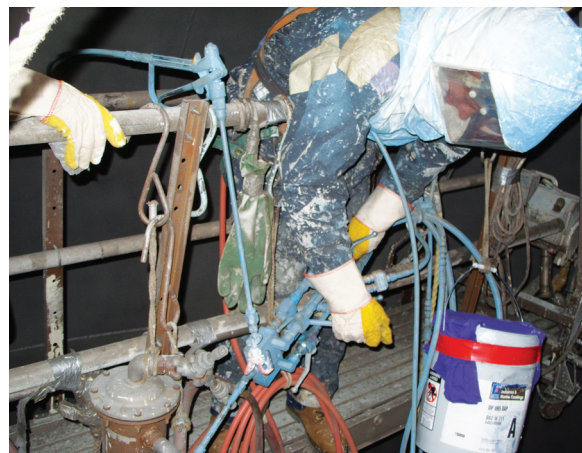
Workers applying primer with optically active pigment

Using the UHS primer in conjunction with OAP yielded several immediate benefits as well. Typically, an inspector at the job site has to wait several days for the paint to dry. If holidays are found in the inspection, the coating has to be touched up and allowed to dry before it can be inspected again. In this case, however, OAP technology in the paint allowed the inspection for holidays to take place while the coating was still wet.

"Holiday testing is usually done on weld seams, but not typically in the middle of the steel plates. But the OAP primer proved very effective for inspecting the middle of the tank plate and the floors or riser," Mumford said. "When we shined the UV flashlight inside the tank, we could see right away where the painting contractor missed. We could also check 100% of the surfaces pretty quickly."
